VEHICLE CRASH TESTS OF THE TYPE 70  
BRIDGE RAIL

FINAL REPORT # FHWA/CA/ESC-98-06

STATE OF CALIFORNIA  
**DEPARTMENT OF TRANSPORTATION**  
DIVISION OF NEW TECHNOLOGY,  
MATERIALS AND RESEARCH

<b>16. ABSTRACT</b>  <p>A bridge rail Type 70 was built and tested in accordance with NCHRP Report 350. The Type 70 bridge rail is an 810 mm tall concrete barrier with a sloping face of 9.1 degrees from the vertical. The barrier tested was 22.9 m long and was constructed at the Caltrans Dynamic Test Facility in West Sacramento, California.</p> <p>A total of four crash tests were conducted under Report 350 test Level 4, one with an 820 kg car, two with 2000 kg pickup trucks and one with an 8000 kg van truck. Both the 820 kg and the 8000 kg tests were within the limits of the Report 350 guidelines. The first test of the 2000 kg pickup was unsuccessful due to a snagging problem with a floating hub on its extended rear axle. The problem with the first pickup led to a retest with a different pickup that did not have the extended floating rear hub. The second test was successful, with all results within the guidelines.</p> <p>The Type 70 is recommended for approval on California highways requirin

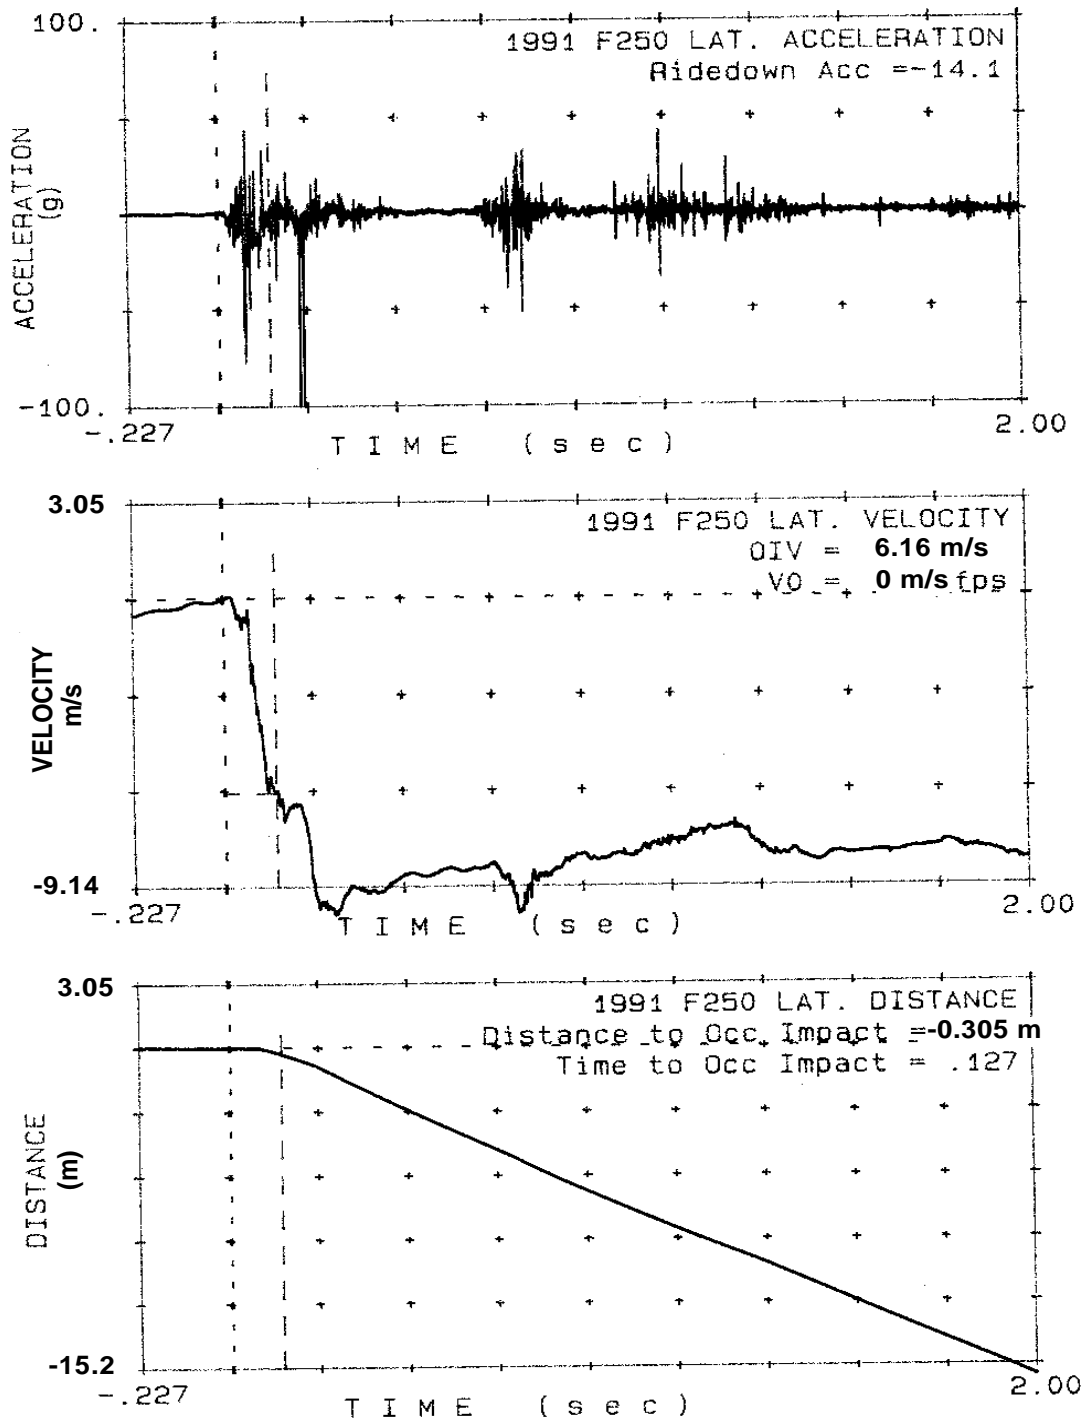
Test #515 TYPE 70 BRIDGE RAI Date: 7/23/97

**Figure 7.14 - Test 515 Vehicle Lateral Acceleration, Velocity and Distance -vs- Time**

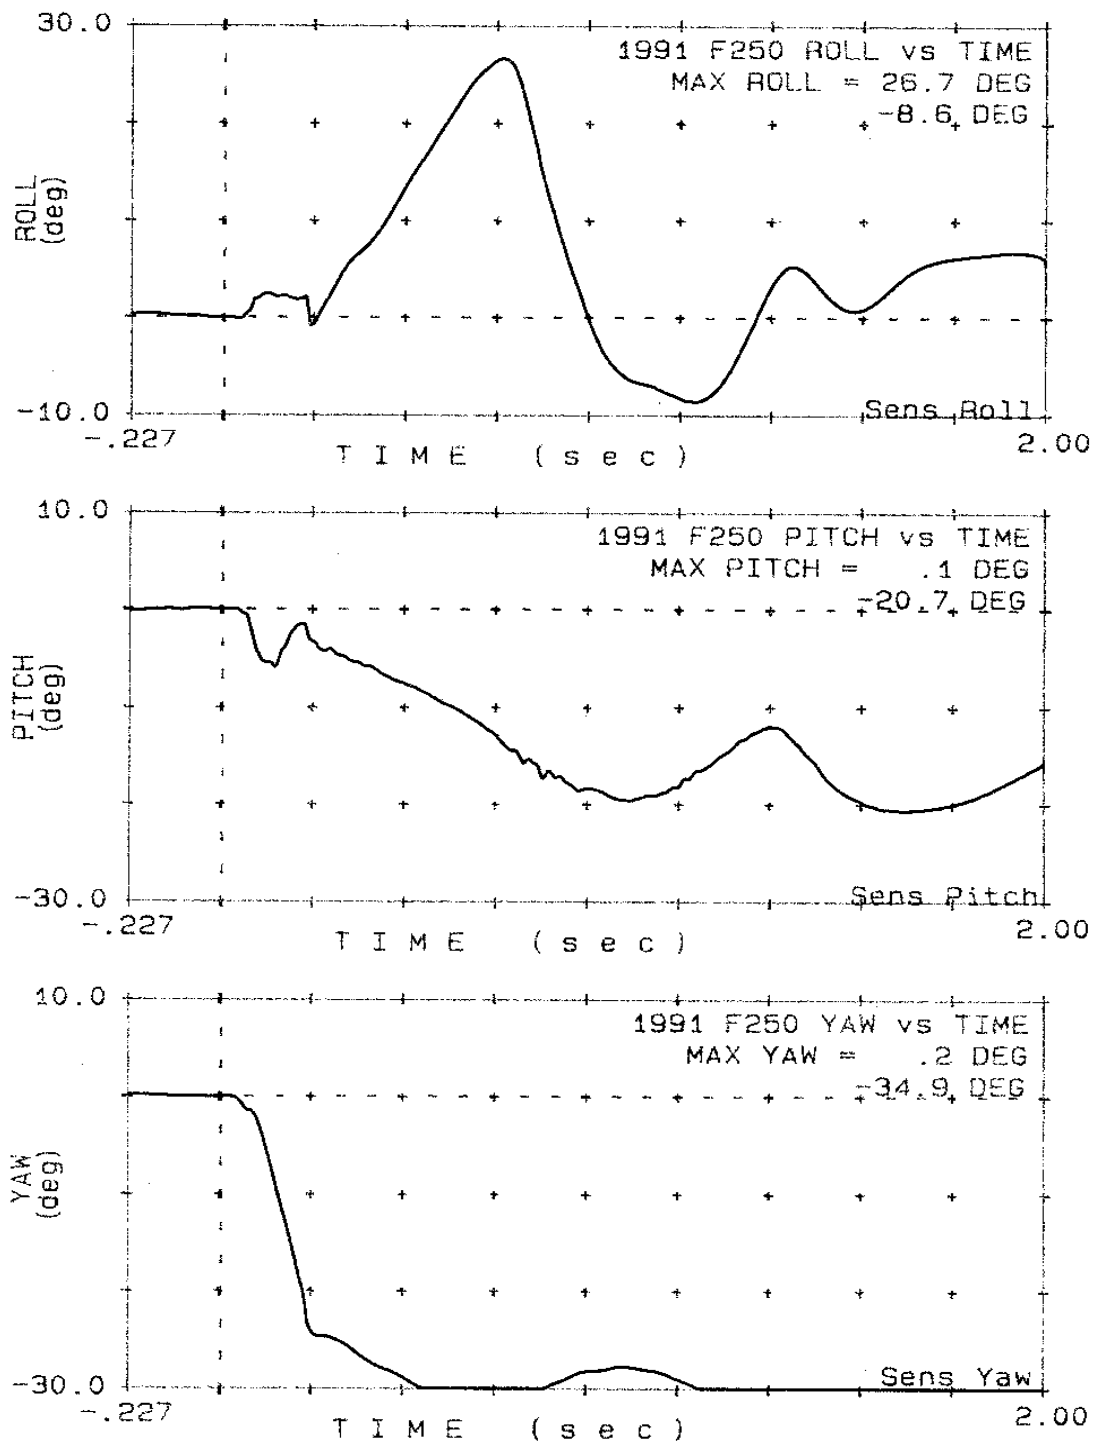
Test #515 TYPE 70 BRIDGE RAI Date: 7/23/97

**Figure 7.15 - Test 515 Vehicle Roll, Pitch and Yaw -vs- Time**
